Splice Damage Detection—Example

FENNER DIAGNOSTICS

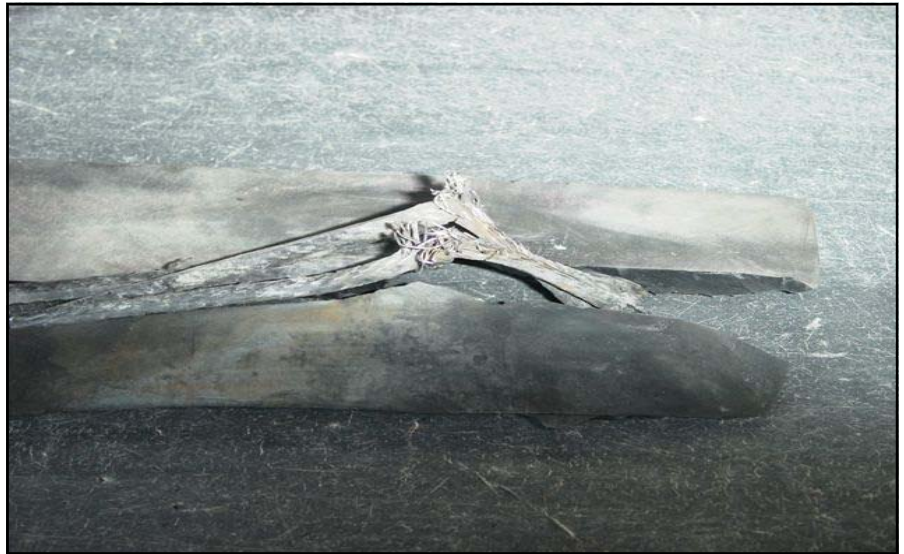
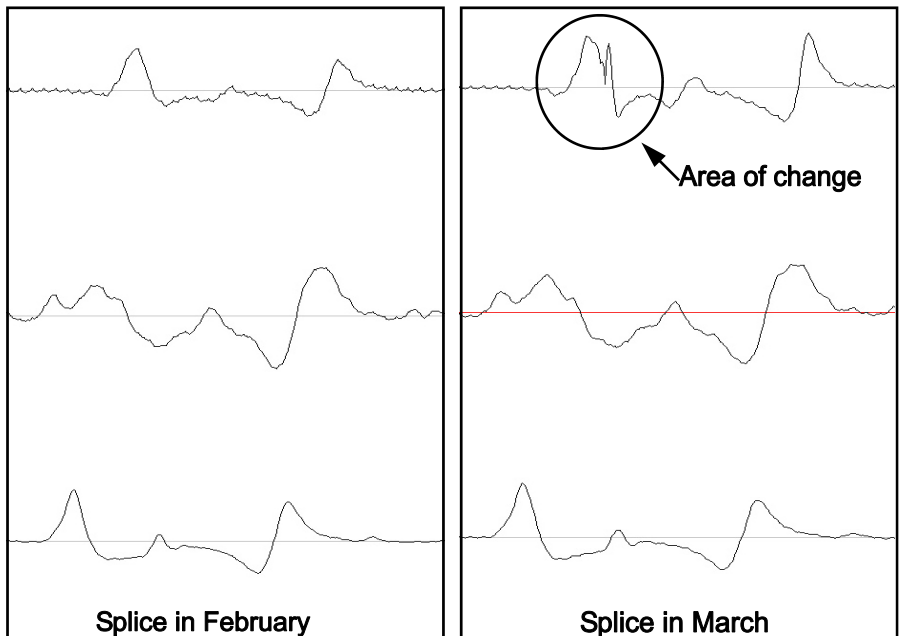
Above is shown a magnetic splice signature for one splice in February and in March.

A change to an area in the leading left of the splice was noted during the March scan.

Onsite inspections revealed that two cords had looped out of the splice and had broken whilst a third cord was damaged. Repairs were able to be quickly made to prevent any further damage.
